DEAD SEA EARTHQUAKE OF 11 FEBRUARY 2004, ML 5.2: POST EARTHQUAKE DAMAGE ASSESSMENT IN THE WEST BANK, PALESTINE

J. N. AL-DABBEEK AND R. J. EL-KELANI

*Earth Sciences and Seismic Engineering Center (ESSEC),
An-Najah National University, Nablus, P.O. Box 707, Palestine
E-mail: seiscen@najah.edu*

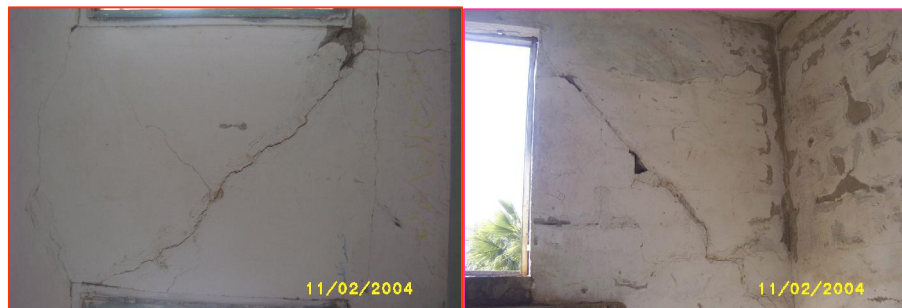
Figure 2. Reinforced Concrete Buildings (Aqraba School).

Three old schools suffered moderate to substantial damage: slight to moderate structural damage and moderate non-structural damage (damage grade 3), see figure 2.

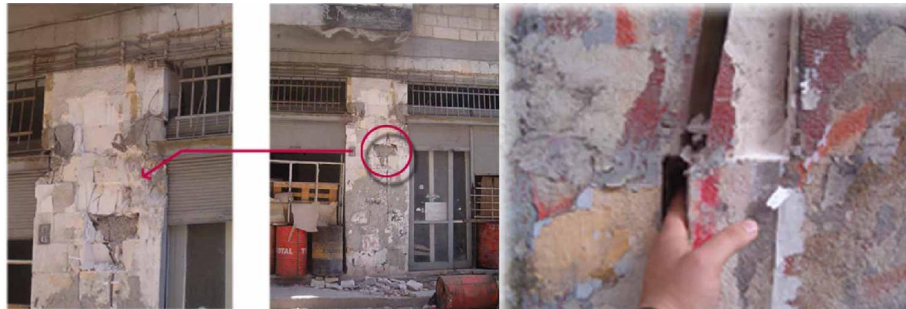
Figure 3. Masonry Building (5 floors), crack patterns in masonry pillars and expulsion of blocks.

The damages that had been occurred had usually been at zone of pre-existing weakness, in the light of the post-earthquake investigations the effected masonry and old masonry buildings suffered with the following damages: crack patterns in masonry pillars; slippage between the blocks; expulsion of blocks in poor mortar stone masonry; large permanent deformation (due to the seismic action); corner detachment; a flat vault's collapse; detachment between few perpendicular walls (in a corner); and crushing in masonry pillars.

Also the Earthquake affected many old masonry buildings in the Palestinian old cities (Jerusalem, Nablus, Hebron, Bethlehem,..... etc), these buildings include hospitals schools and other public buildings (see figures 2 and 3) in Nablus city only few historical buildings have been affected with damages between grade 2 to grade 4: nine old masonry buildings suffered damages grade 2; four old masonry buildings suffered damages grade 3; two buildings (masonry and old masonry buildings) suffered very heavy damage (grade 4).
